DEPARTMENT OF TRANSPORTATION**DIVISION OF ENGINEERING SERVICES**

Contract #: 04-0120F4Cty: SF/ALA Rte: 80 PM: 13.2/13.9File #: 69.15**SOURCE INSPECTION REPORT****Resident Engineer:**Pursell, Gary**Address:** 333 Burma Road**City:** Oakland, CA 94607**Report No:** SIR-000173**Date Inspected:** 23-Nov-2007**Project Name:** SAS Superstructure**OSM Arrival Time:** 630**Prime Contractor:** American Bridge/Fluor Enterprises, a JV**OSM Departure Time:** 1530**Contractor:** Zhenhua Port Machinery Company, Ltd (ZPMC), Changxing Island **Location:** Shanghai, China

SOURCE INSPECTION REPORT

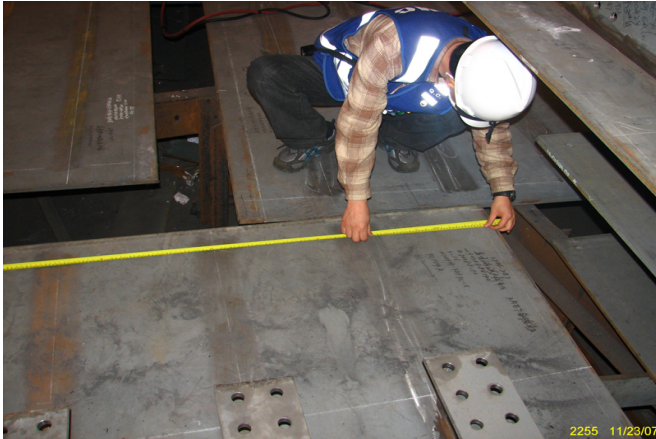
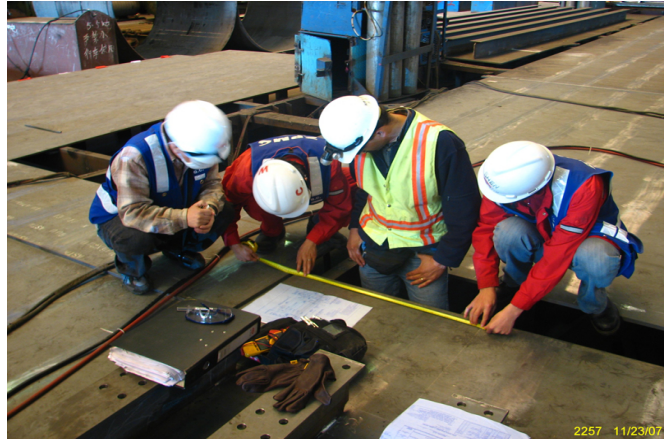
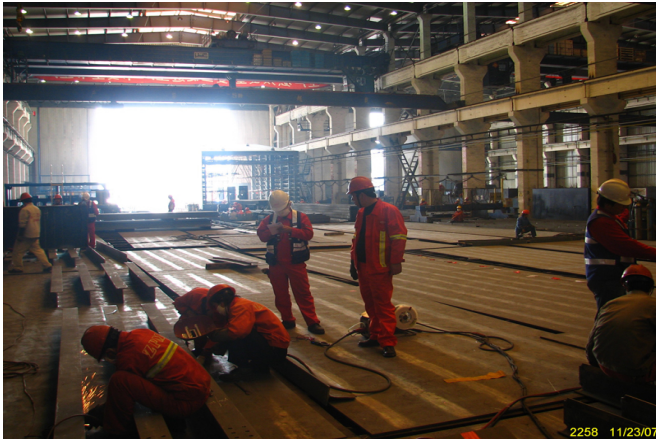
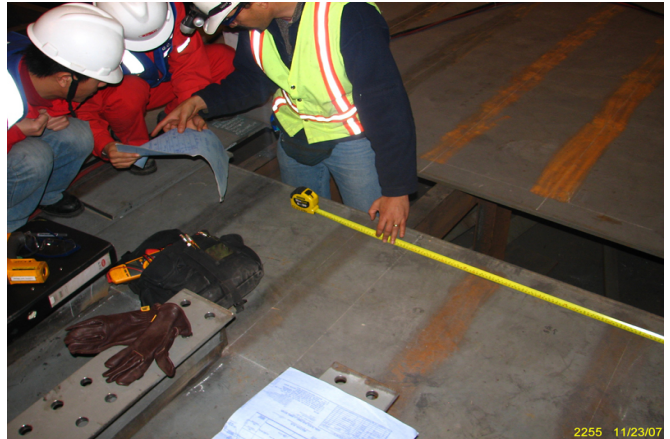
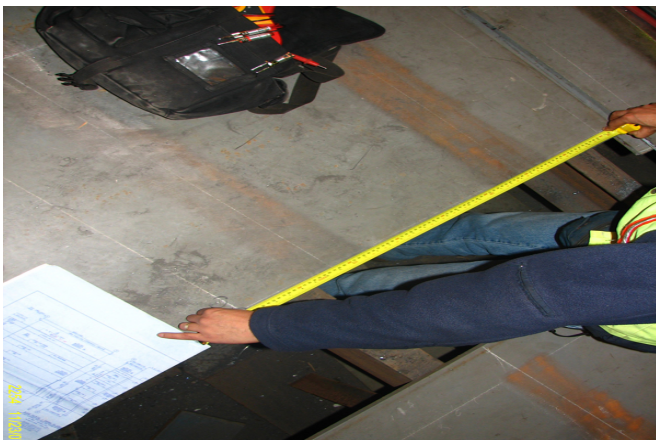
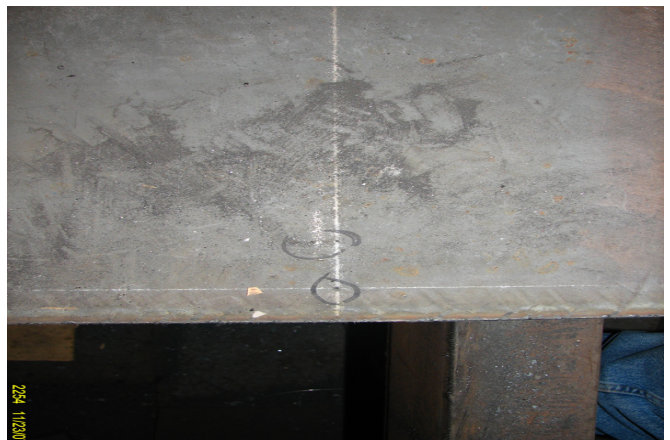
Bay 2: Mr. Acuna and the Caltrans representative spent a couple of hours, in the afternoon, within the tower mock-up (bay 2). 114m mock-up Plate B, Plate A and Plate E were being fabricated. The longitudinal stiffeners were being attached to the skin plates. Mr. Acuna checked material, welding parameters and electrode. All variables observed appear to be in accordance with the criteria set forth within the contractual documents.

Bay 3: Mr. Acuna and the Caltrans representative observed dimensional verification on plate layout. Mr. Acuna was specific about how the stiffeners need to be plotted on the plate, taking in account for welding shrinkage, and cut variances.

Consumable electrode storage area was observed today by Mr. Acuna and The Caltrans representative. The storage oven temperatures in this room, while above the minimum, were only above the minimum temperature of 120 degrees centigrade by 2 degrees. The consumable electrode issuance log was completely written in Chinese characters. Had it not been for the initials "FCM" written at the top of one log book there would have been no way

Included below are digital pictures that support the observations recorded within this report.
